# Closing the quality gap: the science of robotic blade leading-edge repair

How systematic materials research, rain erosion testing and a new generation of robotic systems are reshaping the economics of leading-edge protection in wind turbine maintenance.

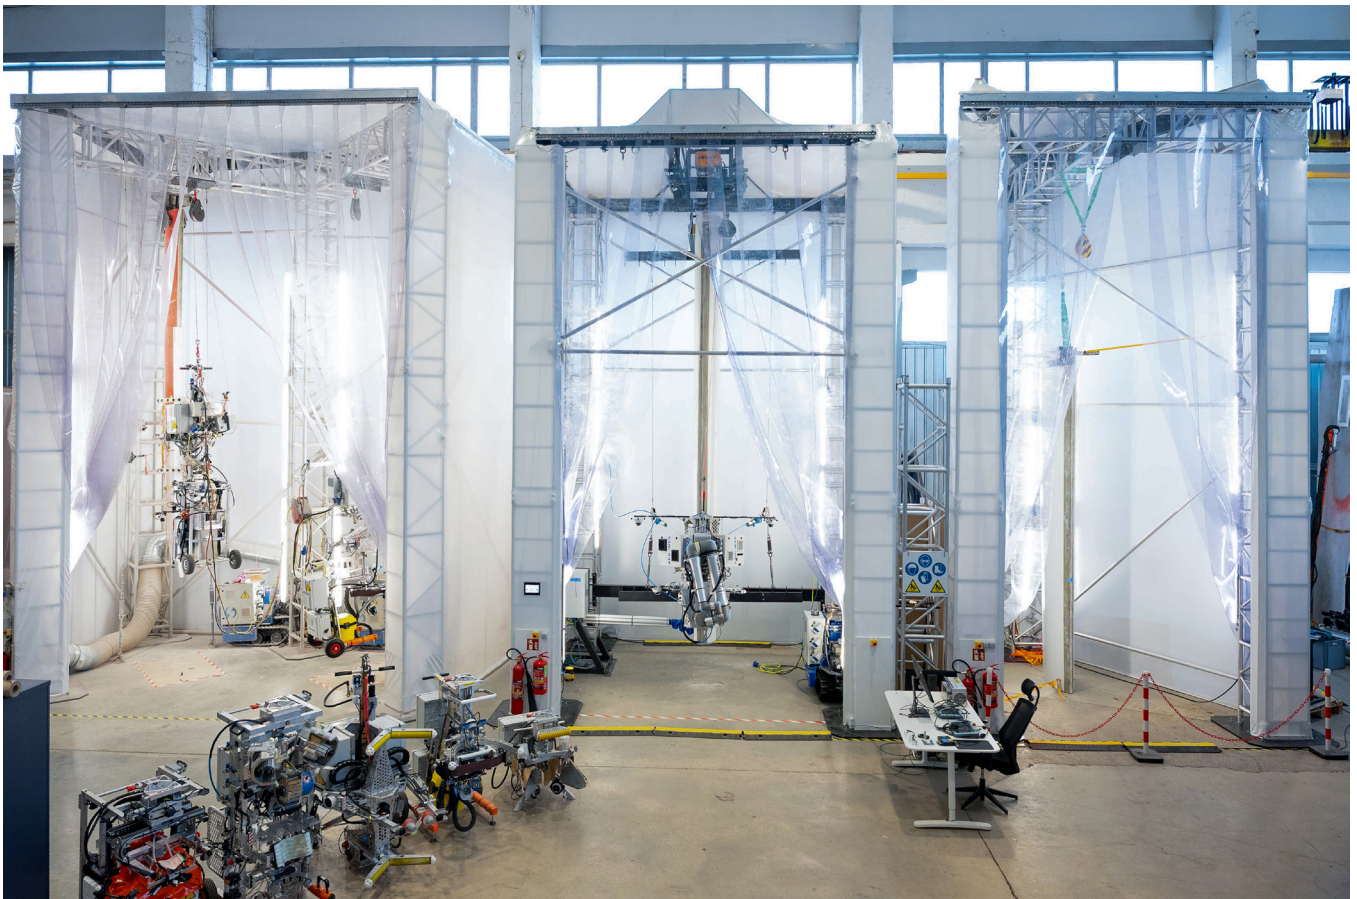
range, a modular suite of robotic toolheads that collectively cover every stage of the repair process.

The system is anchored by the toolbase robot, a blade-holding unit that secures the wind turbine generator (WTG) blade in a stationary position while the various robotic attachments carry out their work. This is a critical design choice: by immobilising the blade, the system eliminates the dynamic instability that makes precise manual application in high winds so difficult.

The repair sequence begins with surface preparation. The designated robotic tool handles surface activation, washing and drying, sanding, removing contamination and creating the surface profile needed for good coating adhesion.

Where 3M erosion protection tape has been previously applied, the optional tape removal unit strips it cleanly before the repair work begins. The next tool then sands the surface to the precise roughness specification required for the subsequent coating steps, preparing it for painting.

Filler application is carried out by the Spatula Application tool, which restores the edge profile by applying filler material, either a standard two-component epoxy or polyurethane filler, or a pullable LEP system, to a consistent geometry.

Once the filler is cured, the grinder returns for a second sanding pass to remove surface imperfections and achieve the required smoothness, followed by cleaning to remove residual dust. Finally, the robot applies the leading-edge protection coating using a sprayable system to deposit a uniform, controlled-thickness layer across the full repair zone.

The full seven step process: tape removal, sanding, cleaning, promoter application, filler, sanding and cleaning again, then LEP coating, can be completed by the Aeronex robotic system in approximately 20 hours of active work at the turbine, equivalent to two regular working days at 10 hours each.
