Reducing wind turbine gearbox and bearing failures

Words: Nick Weldon, Technical Marketing Manager, Croda Europe Ltd

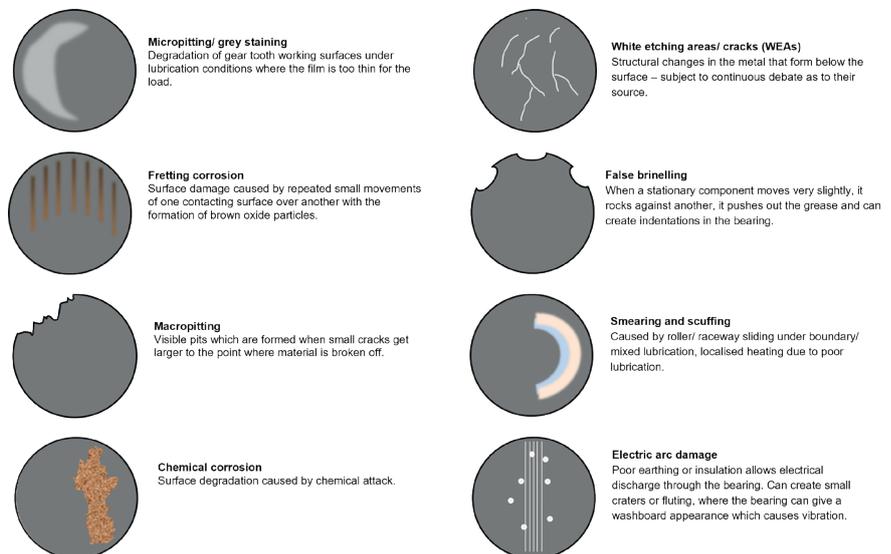
Figure 1: some of the main damage and failure modes within wind turbine gears and bearings

These factors can cause specific wear patterns to develop; figure 1 details some of the main damage and failure modes within wind turbine gears and bearings.

prevents the lubricant from working, causing false brinelling and fretting damage (as shown in figure 1). Adding REWITEC optimises the existing standard lubricants: the technology adheres to the steel surface of component and protects it, even if it experiences poor lubrication.

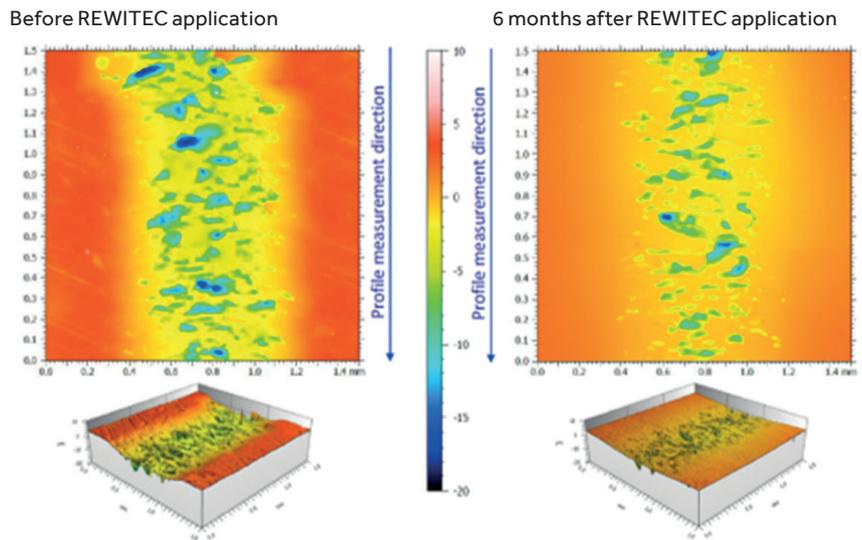
Figure 2: Main bearing surface of a 1.5 MW wind turbine before and 6 months after REWITEC application

Figure 2 shows how REWITEC improved the condition of the surface of a 1.5 MW wind turbine main bearing. Roughness has been reduced by more than 50%; the surface is more uniform, which leads to better load distribution and reduced stress on the component. This improves the main bearing reliability and lifetime.

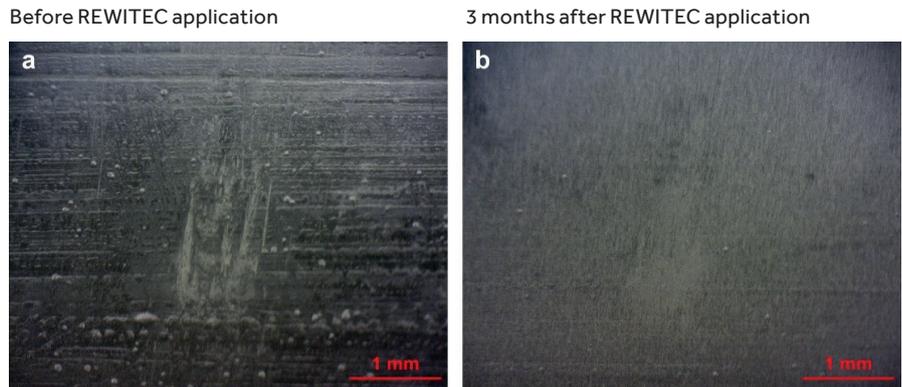
Figure 3: Tooth flank imprints of the high-speed shaft in a wind turbine before and 3 months after the application of REWITEC

The same imprint technique was used to analyse a gear on the high-speed shaft of a 1.5MW wind turbine. Figure 3 displays a micrograph of the imprint before and three months after treatment with REWITEC. The first imprint (a) was taken before the application of REWITEC. It shows running traces and notable micropitting. The second imprint (b) was taken three months after the treatment. The same area of the tooth flank is clearly visible: The micropitting is repaired and there are no running traces. There is a significant improvement in the surface condition, and this ensures that loads are spread more evenly, and surfaces are protected from additional stress and wear.

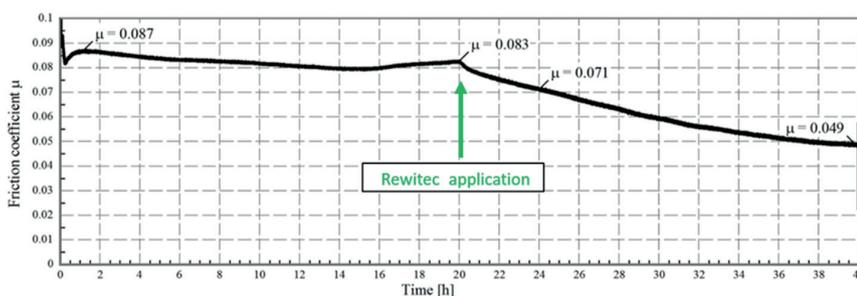
Figure 4: Friction measurement in industry standard wind turbine gear oil with REWITEC added after 20 hours using a 2disk test rig

The system tested was set up to replicate the forces experienced in a wind turbine gearbox with an industry standard wind turbine gear oil. Figure 4 shows how friction was reduced by 40% after REWITEC was introduced to the system; REWITEC significantly reduces friction, wear and surface roughness.

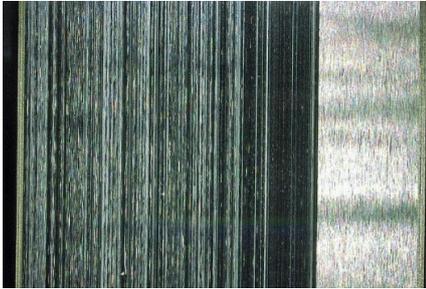
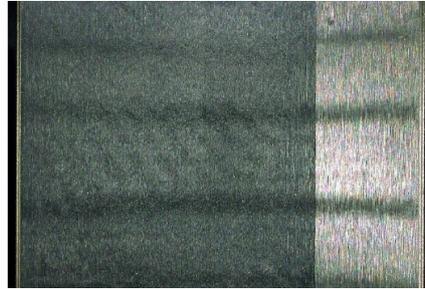
Disk surface without REWITEC

Disk surface with REWITEC

Figure 5: An example of the typical surfaces treated on a 2disc test rig with and without the addition of REWITEC

Figure 5 displays the discs from the test. REWITEC significantly reduces surface roughness.

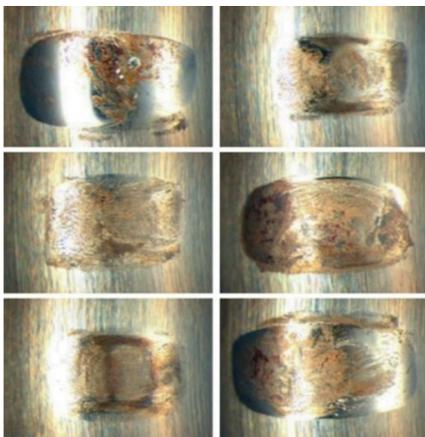
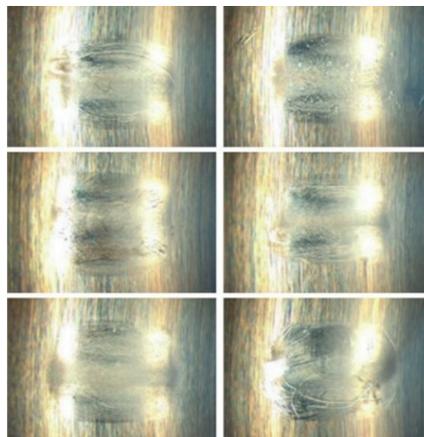
Surface without REWITEC

Surface with REWITEC

Figure 6: Standstill damages generated with a false-brinelling-test without and with the addition of REWITEC.

Figure 6 shows how REWITEC products protect the surface during a false brinelling tests, and reductions in wear of up to 75% were measured.

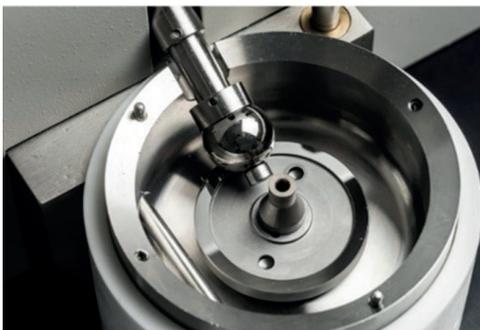
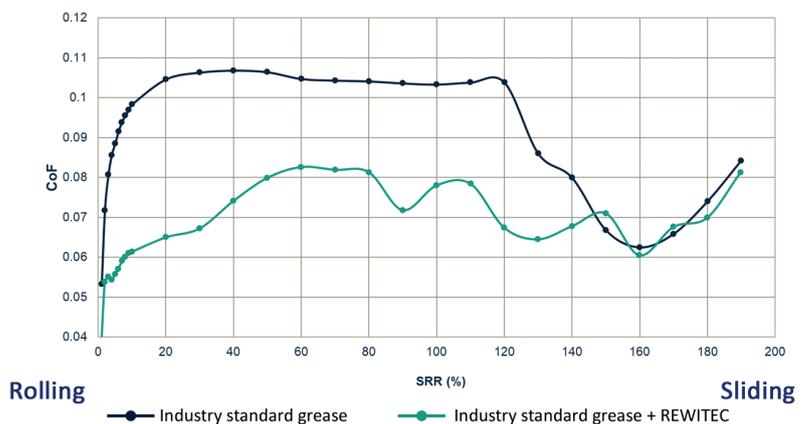
Figure 7: Coefficient of friction at different rolling/sliding ratios in industry standard wind turbine grease without (blue) and with (green) REWITEC.

Figure 7 shows the measured friction with and without REWITEC in a standard wind turbine grease across a range of rolling and sliding conditions. The level of friction was reduced by up to 40%.

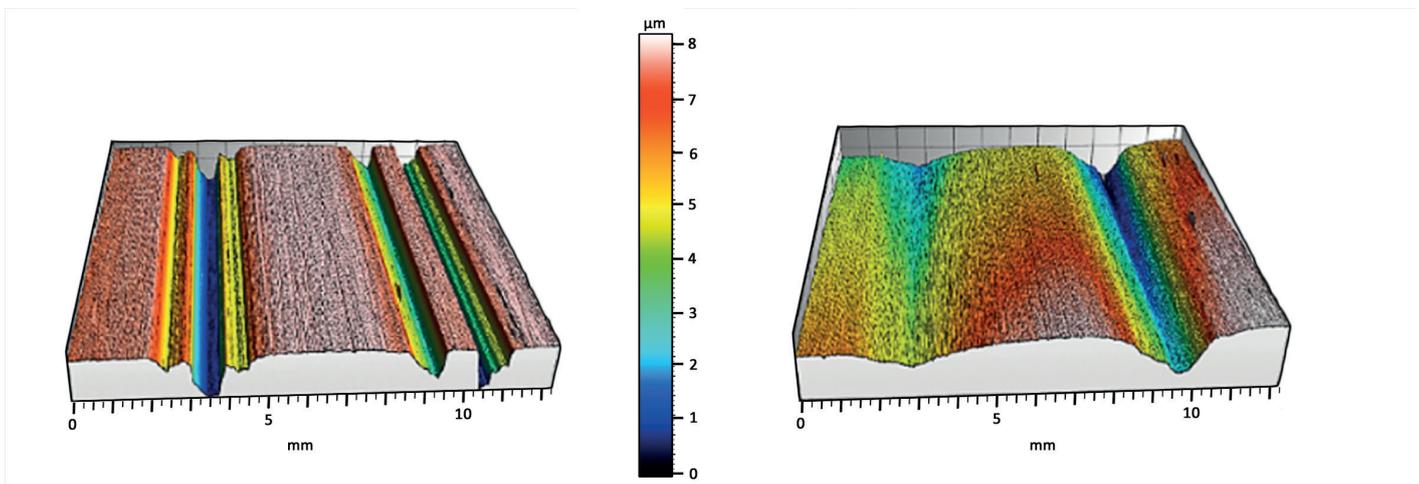
Surface profile without REWITEC

Surface profile with REWITEC

Figure 8: Profilometry analysis of the metal surface after the FE8 test in an industry standard wind turbine gear oil without and with REWITEC

REWITEC was also tested in another industry standard wind turbine gear oil using an FE8 test. This is a specialist bearing test, designed to determine the wear behaviour of lubricants on roller bearings and using it, the effect of REWITEC on surface roughness was measured. Figure 8 shows the results after profilometry analysis with and without treatment with REWITEC. With the REWITEC treatment (right image), the metal surface is smoother and less damaged. This leads to a better load distribution and longer bearing life. A reduction in wear of 20% was measured. Figure 9 shows photographs of the same metal surfaces. The left image shows much deeper wear tracks compared to the surface lubricated with a REWITEC treated oil.

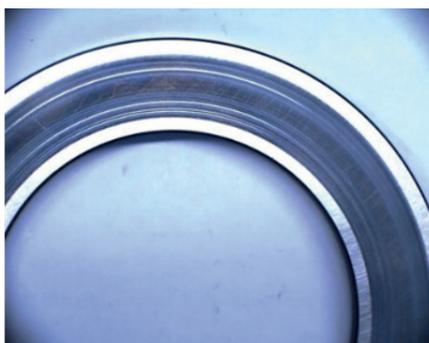
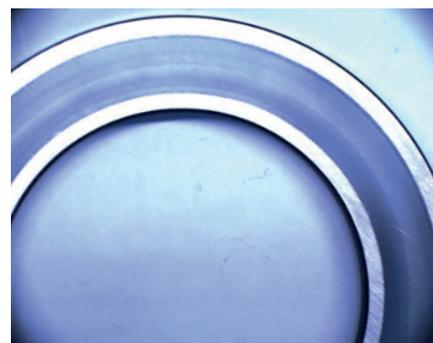
Disc surface without REWITEC

Disc surface with REWITIC

Figure 9: Photographs of the metal surface after the FE8 test in an industry standard wind turbine gear oil without and with REWITEC.
