# Monitoring and analytics enhances solar plant performance

Solar plants are adopting digital tools to improve site performance, with mixed success. Traditional asset performance management (APM) tools focus primarily on inverter data and DC-side performance issues but pay very little attention to tracker performance. Most tracker analytics are manual and focus mainly on actual versus expected angle trends. With a lack of detailed tracker data, field teams are forced to troubleshoot issues in the field with limited information. The approach is time-consuming, expensive, and full of guesswork. This case study showcases how SUNOPS helped efficiently identify, diagnose, and resolve tracker performance issues at a 100 MWdc solar plant in the Mountain West Region.

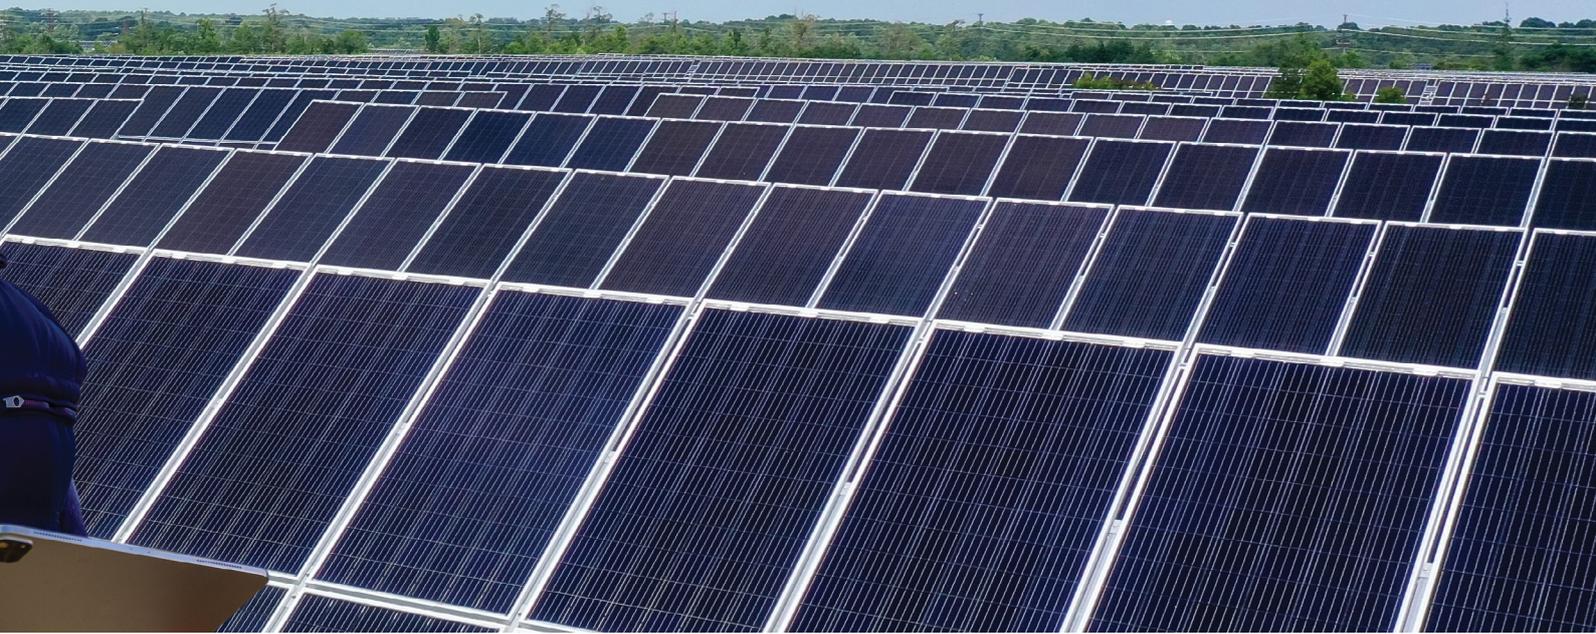
SUNOPS is a cloud-based asset monitoring platform that provides advanced tracker analytics and insights. By aggregating all tracker performance data, it gives users immediate visibility into performance issues. Using the platform, asset managers and other stakeholders can remotely detect and diagnose tracker underperformance, eliminating expensive on-site trial and error troubleshooting and enabling field teams to resolve issues efficiently.

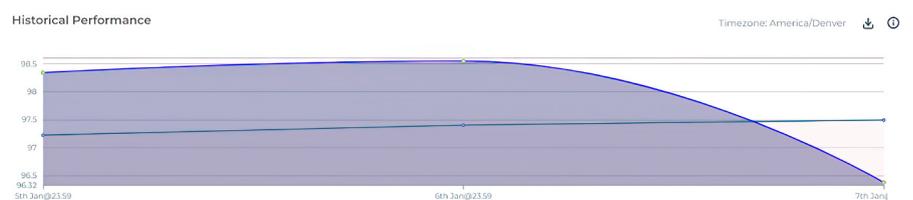
Figure 1: SUNOPS Historical Performance view reveals declining availability

In January 2022, SUNOPS was monitoring tracker data at a 100 MWdc solar site in the Mountain West Region when it identified a serious performance issue. It provided the following key insights. The plant began to underperform in January 2022; availability hit a low on January 7<sup>th</sup>, at 96%. Over Current Faults were identified as the primary reason for underperformance, and trackers went into safety stow in response to the fault, resulting in a drop in availability.

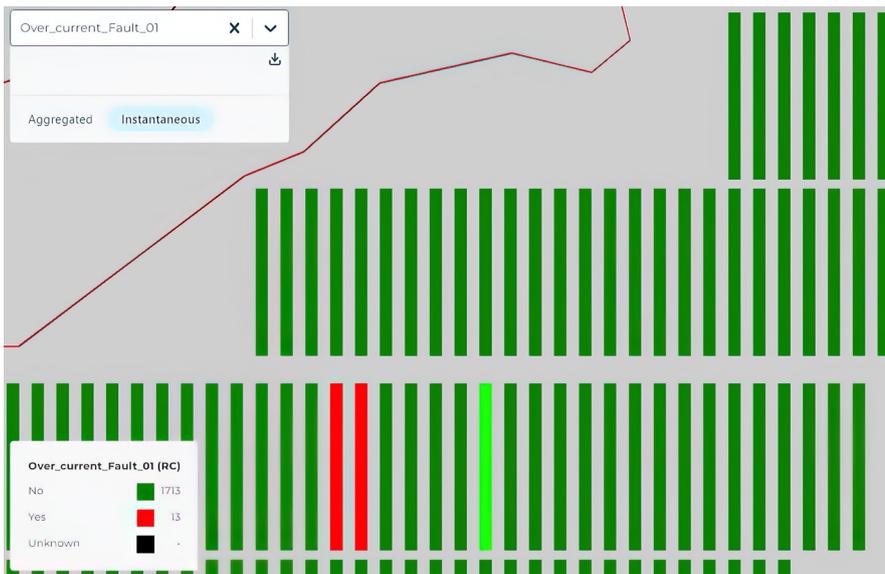
Figure 3: SUNOPS Model Viewer shows all trackers and arrays, enabling field teams to easily locate the trackers in need of repair

Using the SUNOPS Site Model Viewer, the team was able to plan the repair activity based on the most efficient work route.
