# Monitoring and analytics enhances solar plant performance

Solar plants are adopting digital tools to improve site performance, with mixed success. Traditional asset performance management (APM) tools focus primarily on inverter data and DC-side performance issues but pay very little attention to tracker performance. Most tracker analytics are manual and focus mainly on actual versus expected angle trends. With a lack of detailed tracker data, field teams are forced to troubleshoot issues in the field with limited information. The approach is time-consuming, expensive, and full of guesswork. This case study showcases how SUNOPS helped efficiently identify, diagnose, and resolve tracker performance issues at a 100 MWdc solar plant in the Mountain West Region.

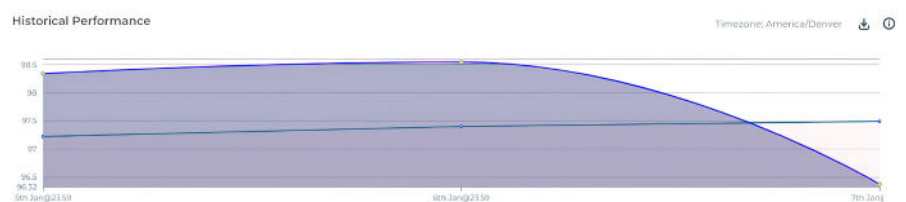
In January 2022, SUNOPS was monitoring tracker data at a 100 MWdc solar site in the Mountain West Region when it identified a serious performance issue. It provided the following key insights. The plant began to underperform in January 2022; availability hit a low on January 7<sup>th</sup>, at 96%. Over Current Faults were identified as the primary reason for underperformance, and trackers went into safety stow in response to the fault, resulting in a drop in availability.

Figure 1: SUNOPS Historical Performance view reveals declining availability

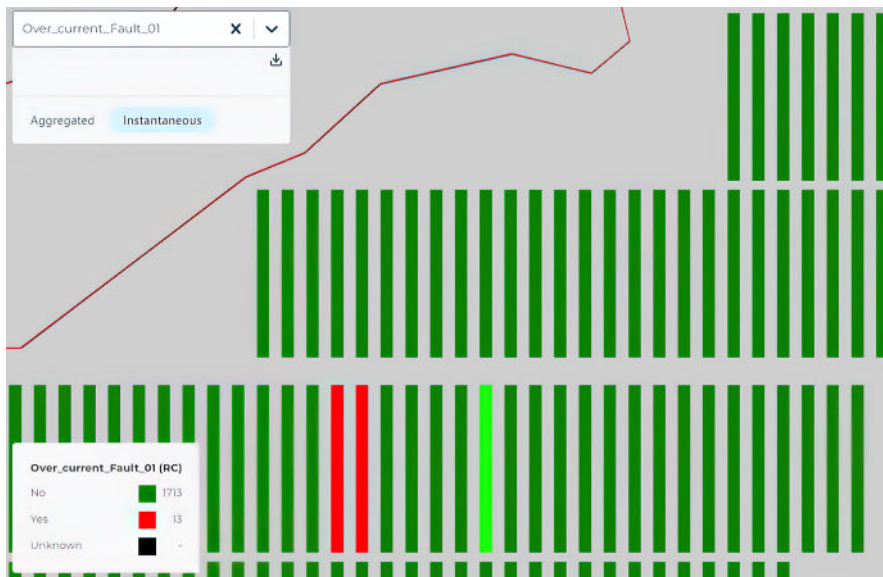
Figure 3: SUNOPS Model Viewer shows all trackers and arrays, enabling field teams to easily locate the trackers in need of repair

Using the SUNOPS Site Model Viewer, the team was able to plan the repair activity based on the most efficient work route.
