Wind turbine energy generation: reliability problems and solutions

Wind turbine reliability remains an issue

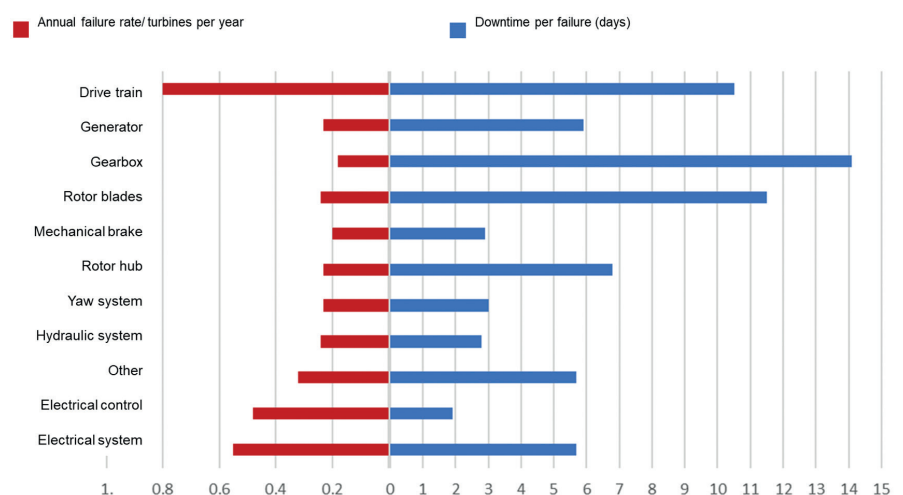
Figure 1: Annual failure rate and downtime per failure by component, adapted from³

The National Renewable Energy laboratory found that the majority of wind turbine gearbox failures are caused by bearings (76.2%) and gears (17.3%)². Figure 1 displays the annual failure rate and downtime per failure by component.

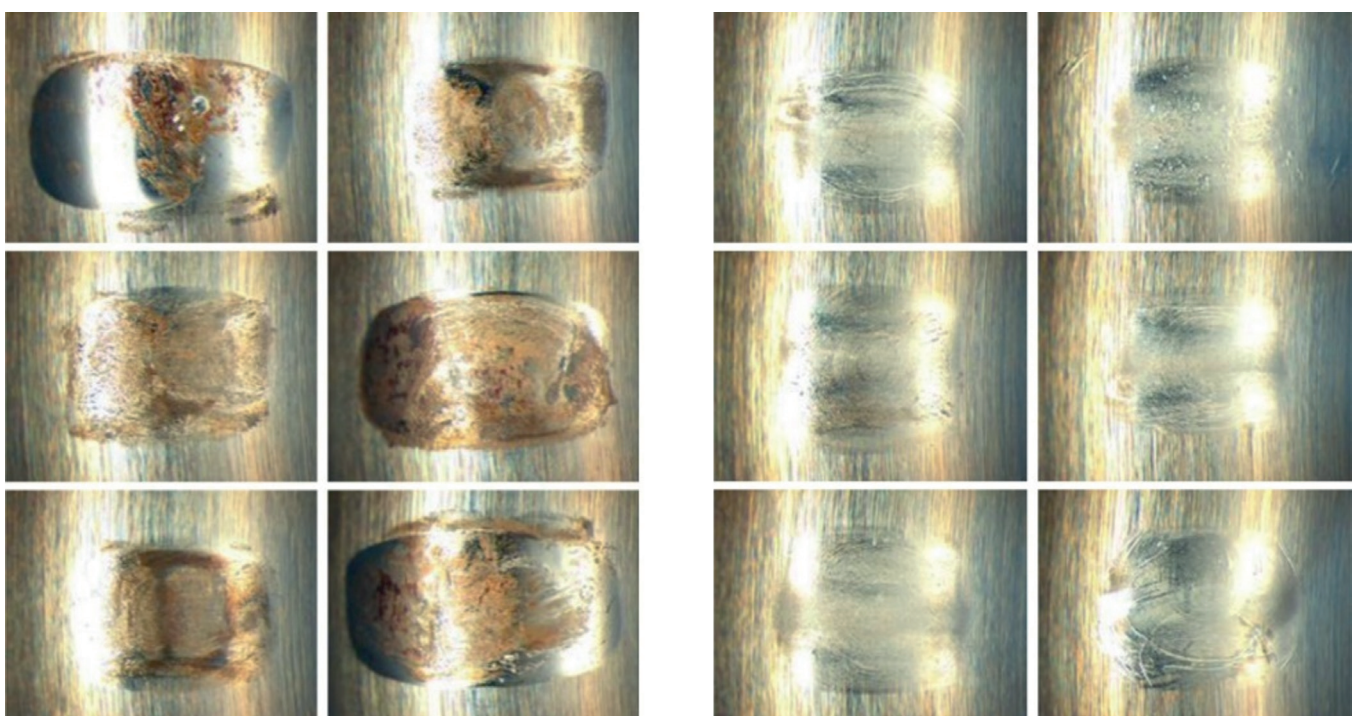
Figure 4: Standstill damages generated through a so called false-brinelling-test without (left) and with (right) the addition of REWITEC.

Standstill damage is a common problem in wind turbines. This occurs in systems where vibrations appear when stationary. Although common lubricants help reduce the damage, they cannot prevent it because of the very poor lubrication due to lack of movement in the system. Adding REWITEC to the lubrication system optimizes classic lubricants: Our silicon-based nano- and micro-particles adsorb onto the steel surface and remain there, even if the lubrication is deficient. We have scientifically analyzed the behaviour of REWITEC-particles through the false-brinelling-test. The experiment results show a significant wear reduction of up to 76%.

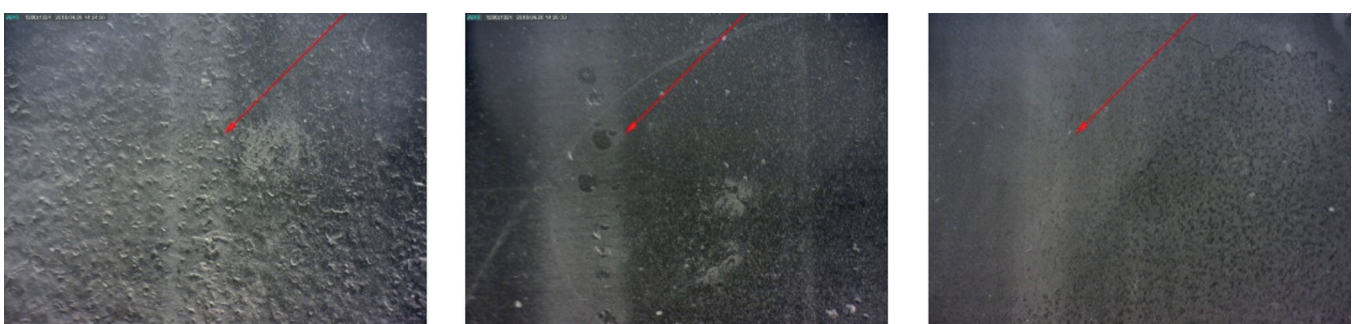
Figure 6: Main bearing imprints of wind turbine GE1.5 MW before (left), 5 months after the application of REWITEC (middle) and 12 months after the application of REWITEC (right).

The main bearing from a 1.5 MW GE wind turbine was analysed (Figure 6). To analyse the wear development over a period of one year, we made several surface imprints. The roughness before treatment was $R_a = 0.556 \mu\text{m}$. Five months after the application, the roughness was reduced by 28 % to $R_a = 0.403 \mu\text{m}$. At the third measurement 12 months after application, roughness was reduced by 60 % to $R_a = 0.225 \mu\text{m}$. We show that the structure and roughness of the surfaces are significantly improved. That means less stress on the mechanical components and a substantial increase in the lifetime.
