# How to upgrade your blades against lightning

**Words:** Allen Hall, Founder and CEO of Weather Guard Lightning Tech

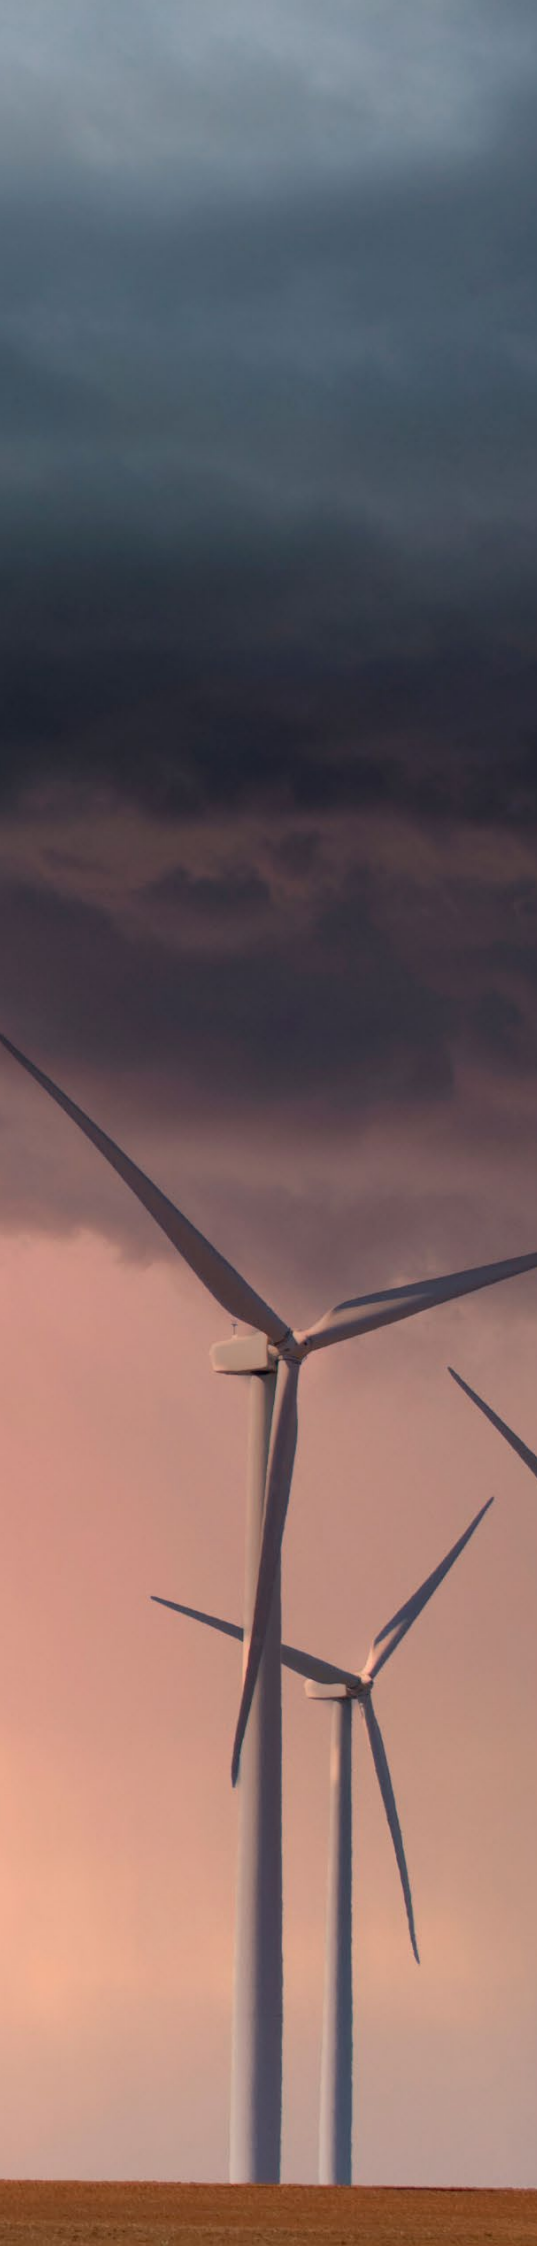
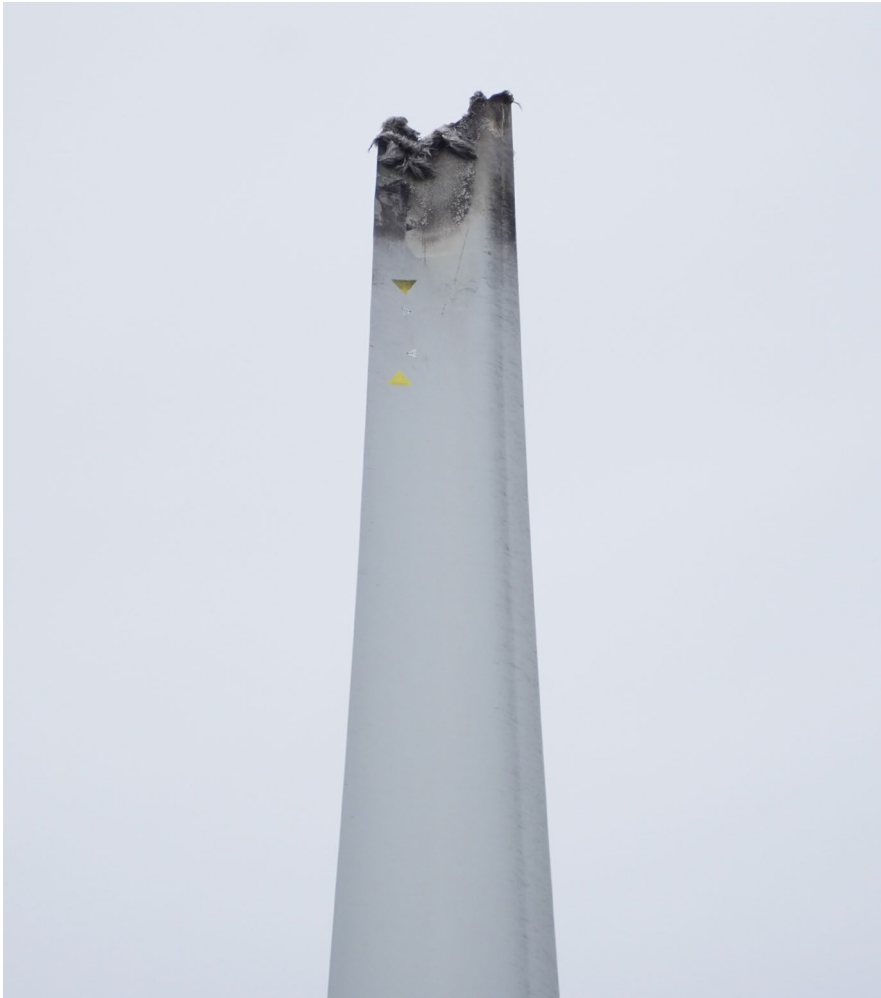
I brought along my newest high magnification lens for this two-week trip so I could photograph blades from the county roads. Some of the photos in this article are from that journey.

So, what is happening in Texas and Oklahoma? In simple terms, lightning is missing the receptor and puncturing the blade structure. I saw some blades with multiple holes from lightning strikes. These holes are easily detected because the damage peels back the outer strands of the laminate, leaving a streak of black on an otherwise white blade. Internally, the lightning will damage the blade structure to reach the insulated down conductor cable.

These blade punctures tend to be several meters from the receptors. Most of the damage I have inspected has been 3 to 5 meters inboard of the receptors, although some operators have reported damage further down the blade. Anecdotally, this would indicate that the LPS is effective at picking up strikes within about 2 meters of the receptors.

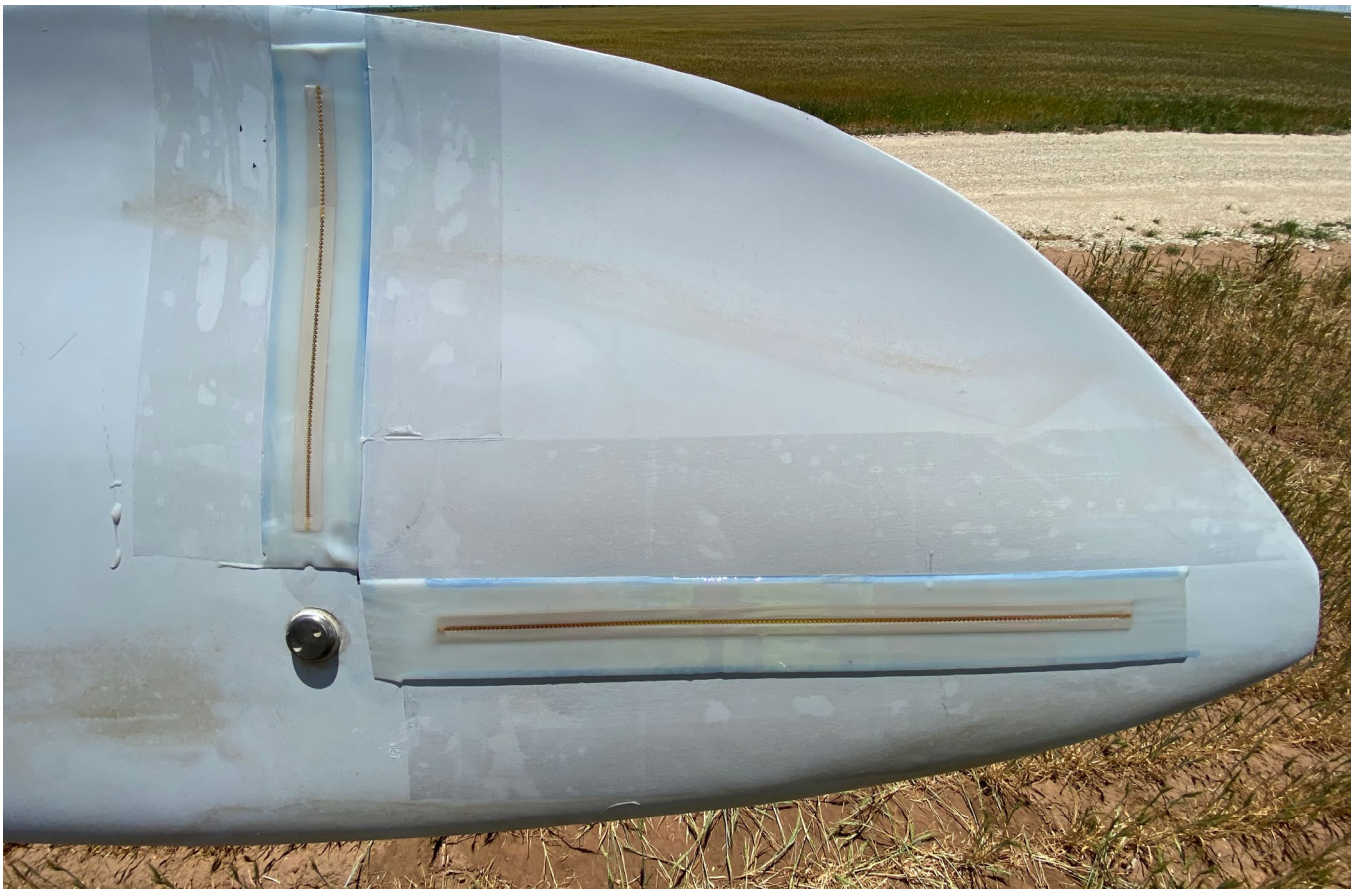
Photos of such strikes are documented in the published papers 'Lightning attachment to wind turbines in central Kansas: Video observations, correlation with the NLDN and in-situ peak current measurements' and 'Lightning Attachment to Wind Turbines in Central Kansas: Video, Observations, Correlation with the NLDN and in-situ Peak Current Measurements in 2013' by Nicholas Wilson, et al.

However, the long-duration current strikes can be preceded by a lower-voltage potentials during the initial phases of the strike. These low-intensity lightning events can evade the receptors and hit the down conductor.
