Guiding inspections and maintenance with condition monitoring

Words: Obdulia Ley, PhD., Subject Matter Expert, Acoustic Emission, Sensoria™

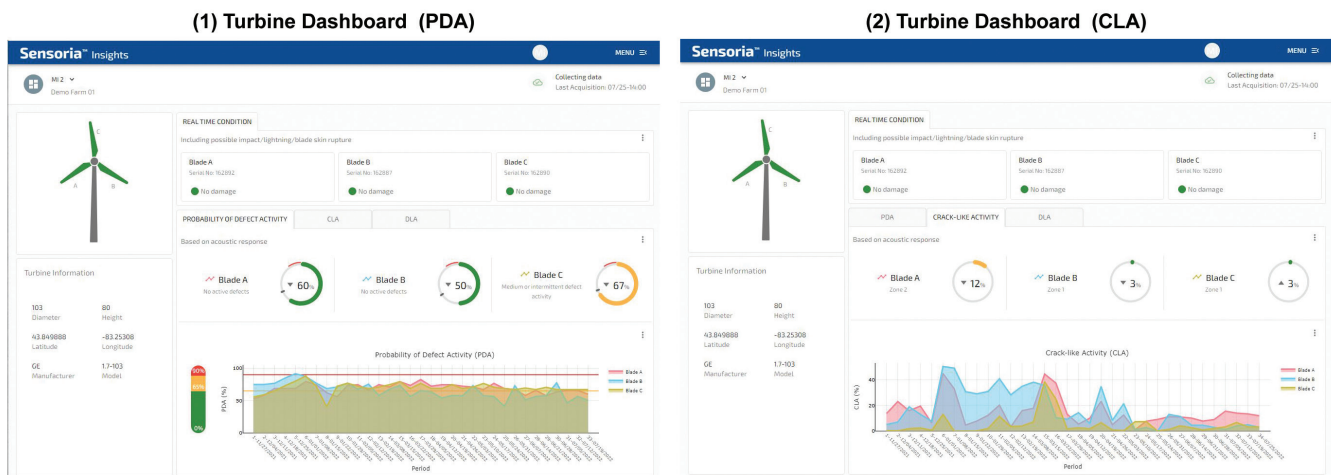
Figure 1: Example of Sensoria's Data Driven Web Application (DDWA) turbine dashboard showing PDA and CLA for a selected turbine. After logging in, the user can toggle through the different SH quantities presented. The progress rings show the current quantity value per blade

blade damages or the formation of new ones. PDA and CLA trends are shown in Sensoria's Data Driven Web Application (DDWA), when accessing the turbine dashboard as shown in Figure 1.

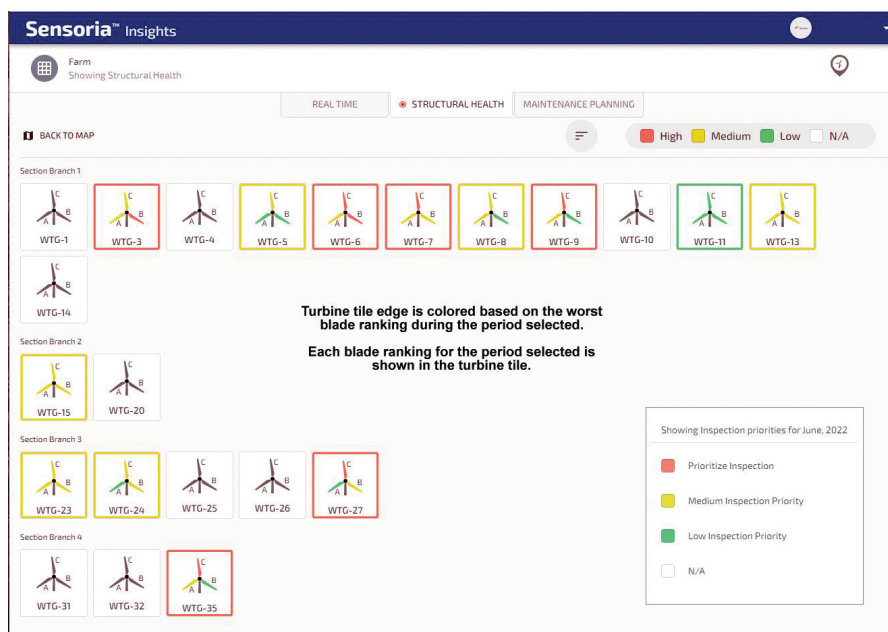
Figure 3: Example of Sensoria's Data Driven Web Application (DDWA) showing the monthly average ranking of the turbines instrumented in a farm. The ranking is performed based on CLA and PDA values, and the classification is based in a model similar to the region plot shown in Figure 2

The ranked list is directly displayed on the DDWA as part of the 'Maintenance Planning' tab, or it can be downloaded as a Microsoft Excel file. The user can also see a graphical representation by accessing the "Structural Health" tab of the DDWA as shown in Figure 3. In this graphic display, the turbine tile boundary will be colored based on categorizing the worst blade in the turbine. The turbine tile also shows the categorization of all blades in the turbine, colored using the scale shown in Figure 2.

When there is insufficient data to perform the analysis, that is the system is not being powered, the turbine tile is shown in gray. The graphic representation of the blades and turbines that require follow-up in figure 3 is based on the severity and level of the acoustic response. It can be used to identify the worst turbines, such as WGT-06 with two blades in red) and the ones that do not require immediate attention, such as turbine WGT-11.

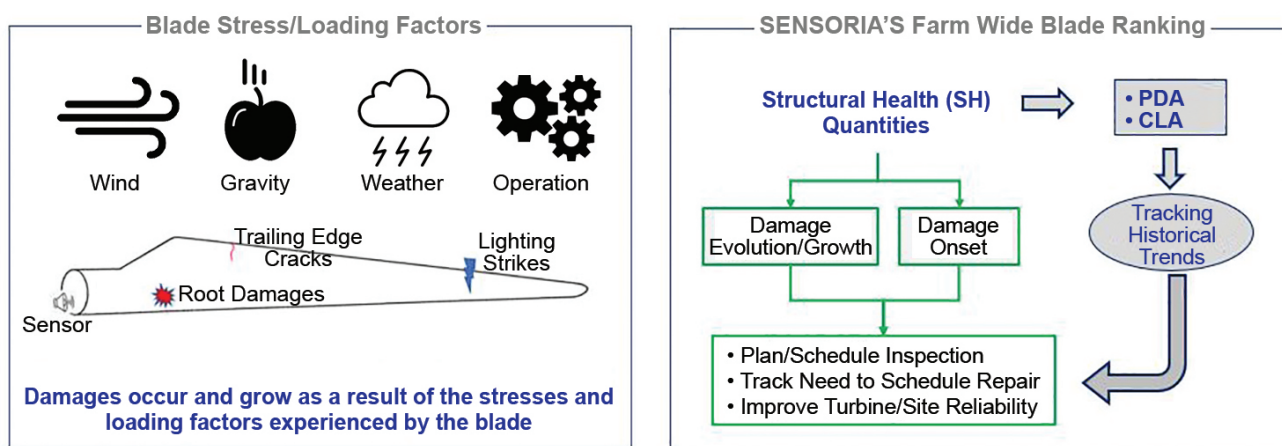
Figure 4: Summary of factors affecting damage growth and evolution wind turbine blades (left hand side), and diagram showing how Sensoria™ offers proprietary SH quantities (PDA and CLA) to track and rank acoustic activity of blades linked to presence of damages

Figure 4 shows a summary of the factors affecting damage onset and evolution, and the use of Sensoria™ to track damages and improve farm management operations. In summary, when using the acoustic ranking, one should consider that not all damages produce an acoustic signature all the time, so the response can vary over time. When a blade has active damage producing acoustic signatures, it will rank higher and will be assigned a higher priority. Finally, when a blade consistently appears in the high inspection priority level over several months, the probability of observing damage that has appeared or worsened is high.

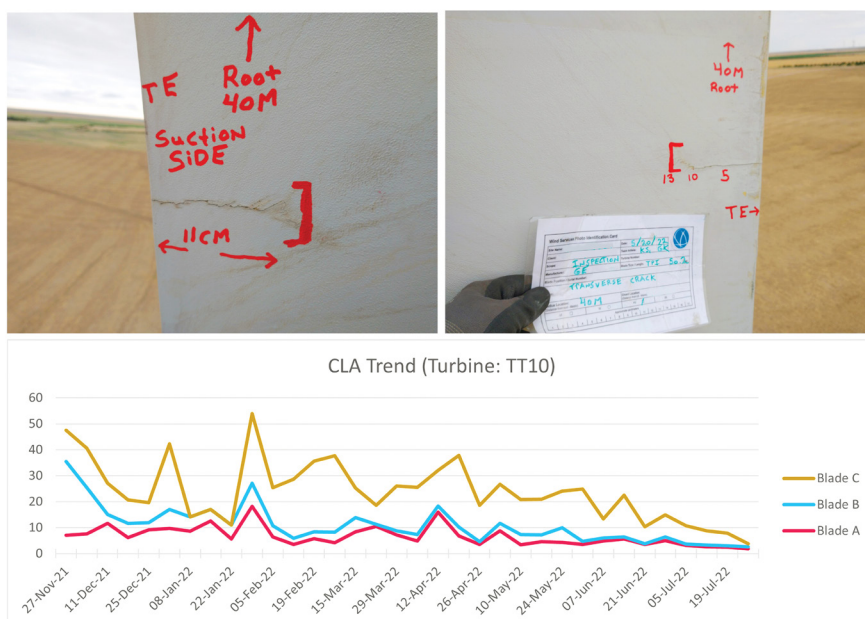
Figure 6: CLA historical trend of Turbine TT10 since system installation. The CLA trend shows increased activity of blade C, where a Trailing Edge (TE) crack in pressure and suction sides (around 32m from the root) was observed after inspection

When comparing the blades classified in red with the existing blade damages shown in Table 1, it is seen that the blades that were ranked higher for inspection are known to have existing cracks. The unexpected result was to see Blade C in turbine TT10 ranked high within the priority list. Follow-up inspection of this blade revealed a Severity 3 trailing edge (TE) crack, as seen in Figure 6, which also shows the CLA historical trend of Turbine TT10 since instrumentation.
