Core solutions from 3WIS

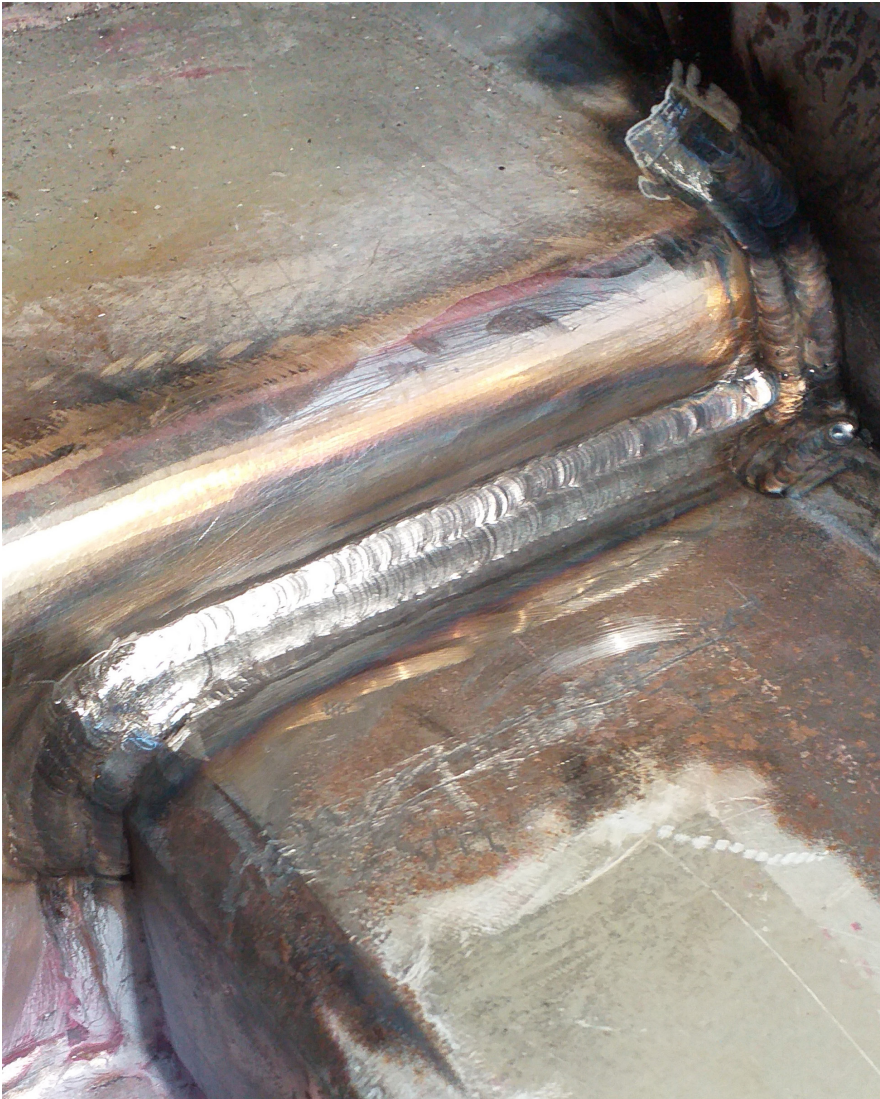
Up-tower solutions: bed frame repair

Damage to wind turbines occurs continuously because of dynamic loads or failures in manufacturing processes.

The bed frame is one of the most heavily stressed components in a wind turbine. Therefore, a sustainable repair is vital to avoid further damage to the component. Particular attention must also be paid to the fire protection and safety of the personnel during hot-work repair up-tower.

3WIS provides on-site repair to meet any client demands and requirements. Not only by delivering the repair, but also by the necessary NDT inspection and following surface protection.

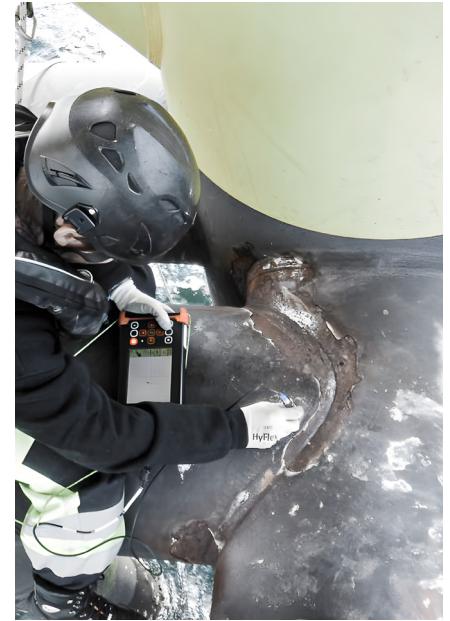
Yaw, pitch repair

A common problem with yaw rings, a vital component for power production, is the teeth can wear down over time.

3WIS offers a welded repair solution performed both onshore and offshore, removing the requirement for replacing the entire yaw ring. This reduces the downtime of the turbine to only a few days. With this solution, the client will avoid the need for lifting down the entire nacelle by crane and will instead receive a repair with a minimum cost and risk.
